Role of Recent Tectonics in The Activity of Wadi Shueib Landslides, NW Jordan.

Al-Awabdeh, Mohammad

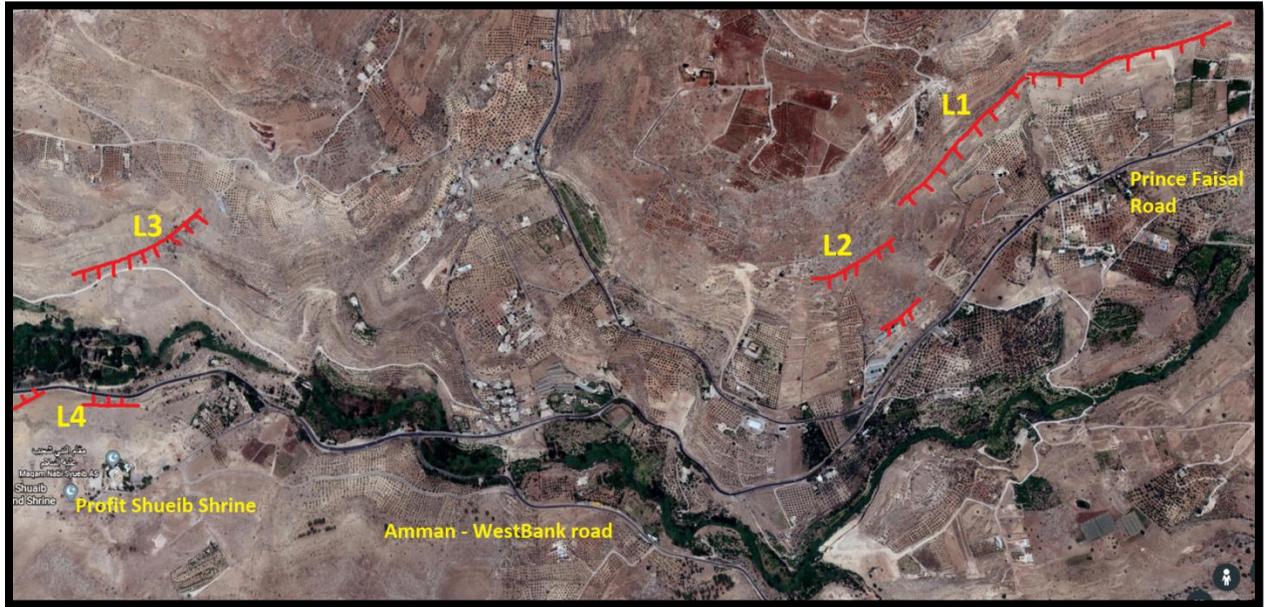
Figure (2): Aerial Photograph of the study area showing the location of the slides. (Google Earth image)

We present the landslides in four sites within a 6 km² and they are named L1, L2, L3 and L4 (Figure 2). Three of these sites show landslides at major scale (L1, L2 and L3) and the fourth one the slide is local and small (< 50m long). The sliding surfaces of the landslides are preserved in L1, L3 and L4 were its possible to measure the slickenside of each movement.

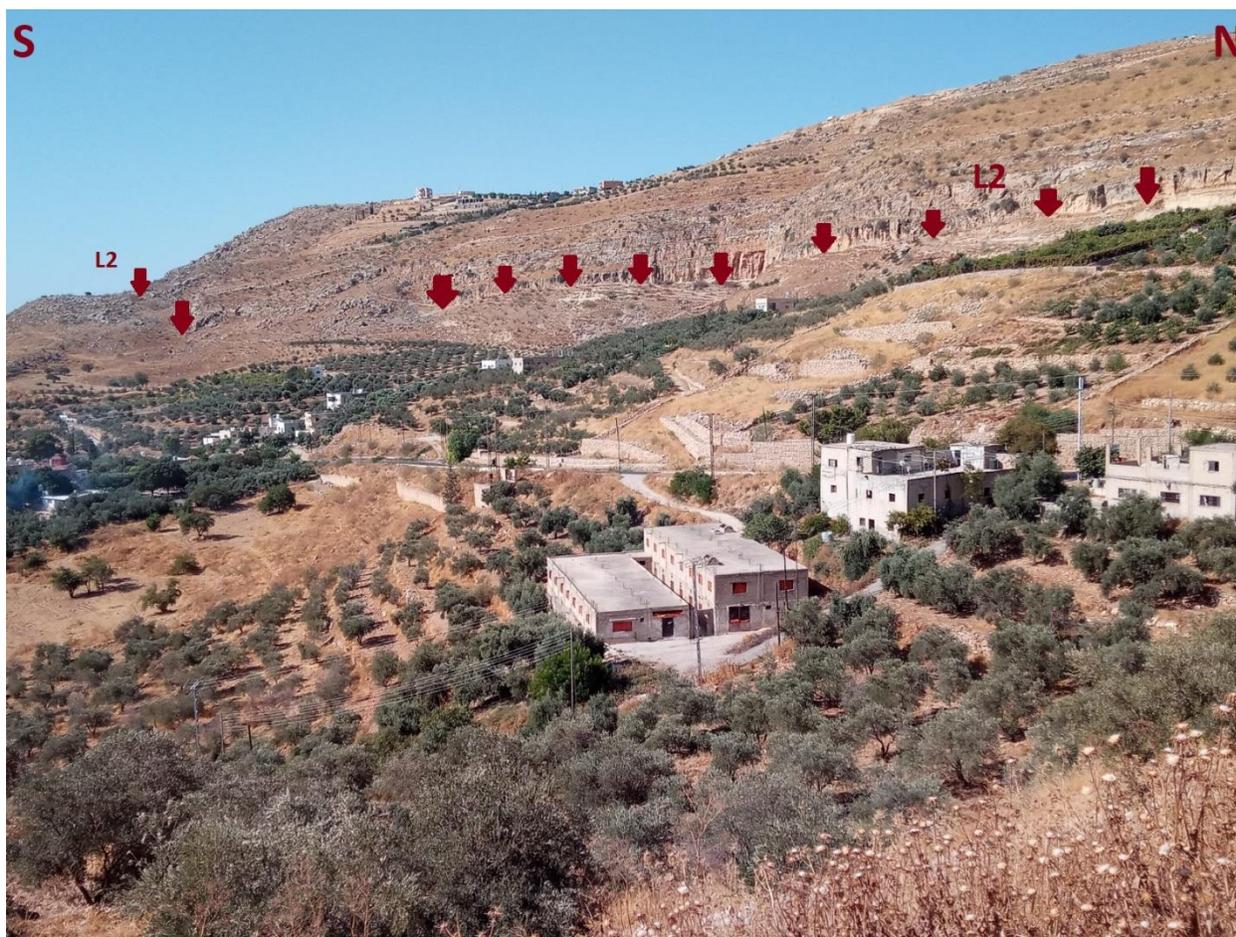
Figure (3) Field Photograph of the L1 and L2 site.

This is the biggest slide in the study area and part of the slided strata are in metastable phase. It extends for about 500 m and the scarp is very clear. The landslide occurred on a major fault plane striking N-S (Figure 3).

This site is active and frequent to have slide. Two different phases of sliding are clear and can be identified in the topographic profiles (Figure 3). The last time of sliding of this site was on 2001. Major tensional and opened fractures can be observed in the field.

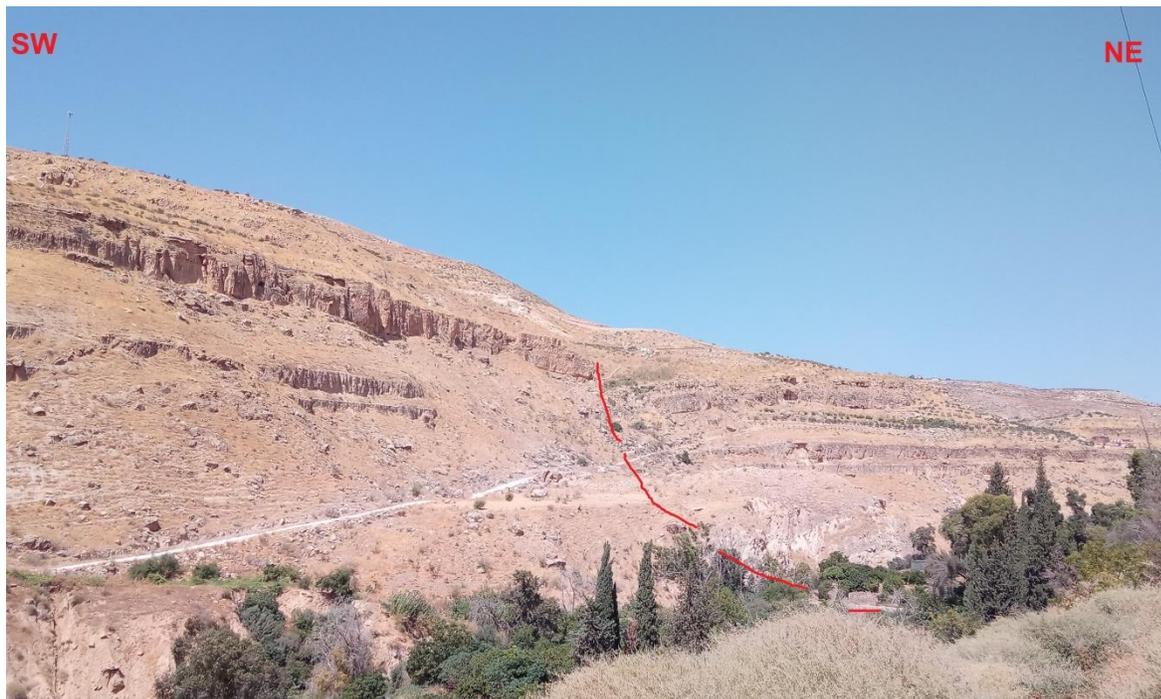
Figure (4): Field photo of the site L3.

In this site, a whole hill is downslided along fault plane. The direction of the slides is NW-SE and is concordant to the transfer zone of the SHS associated normal fault systems (Figure 4). As shown in the figure, the slides strata are rotated along the sliding surface indicating sliding over ductial surface. This surfaces belongs to the Marl layers of the Shueib formation that contains clay minerals.

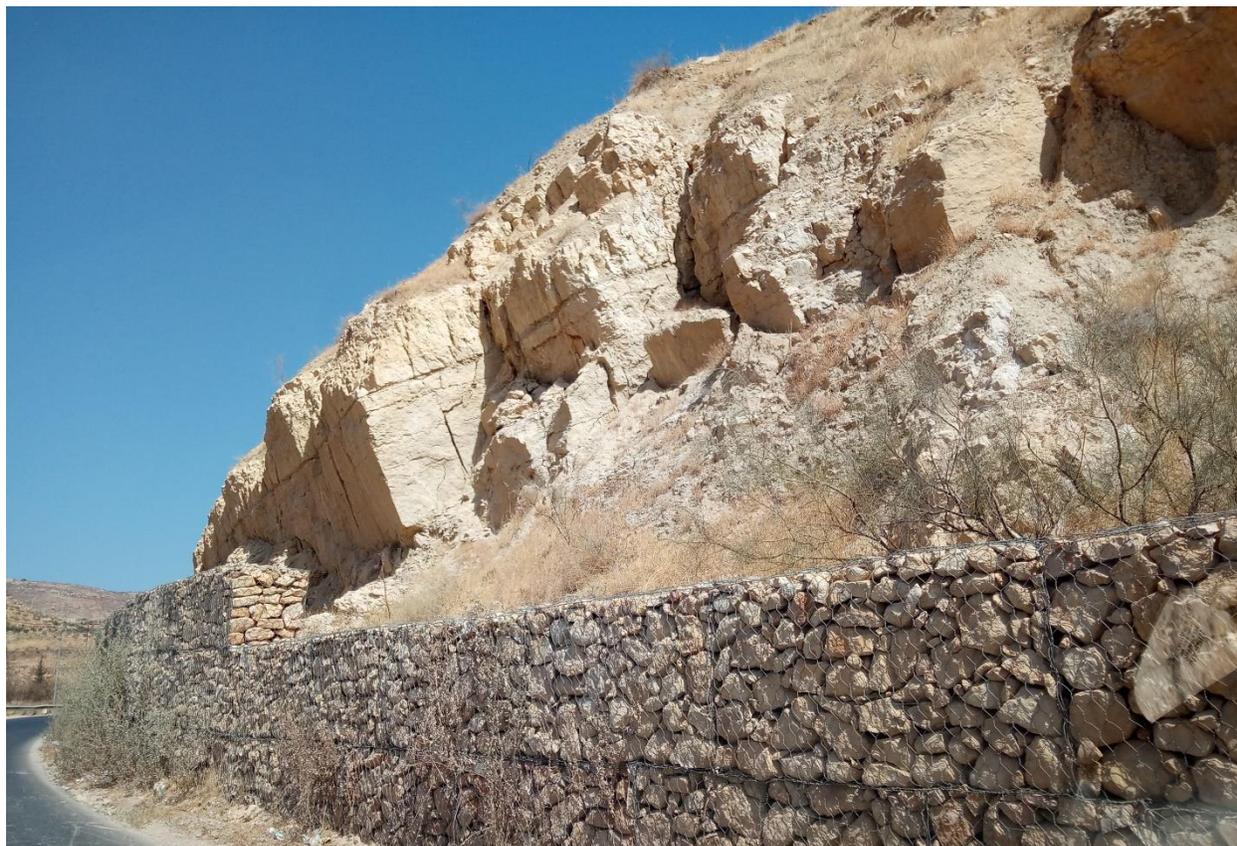
Figure (5): Field photo of the L4 Location.

This location lies on the Main Road connecting Amman and Salt with Jordanian-Palestinian border. From the observation and the type of slide occurring in the site, the most probable mechanism of this slide is the road cut. Some mitigational precautions are already been taken like the gabions and the metal nets (Figure 5). However, the landslides are frequent and associated with heavy rain events seasonally.

The case of L4 emphasizes the situation of the non-engineered road cut and the associated mass-movements. The actual mitigation processes the government follows do not face the demand yielded from the landslides on the main road and yearly road closes are expected.
